ELIZABETH RIVER BASIN  
ELIZABETH RIVER, UNION COUNTY  
NEW JERSEY

**URSINO DAM**

**NJ 00387**

**PHASE 1 INSPECTION REPORT  
NATIONAL DAM SAFETY PROGRAM**

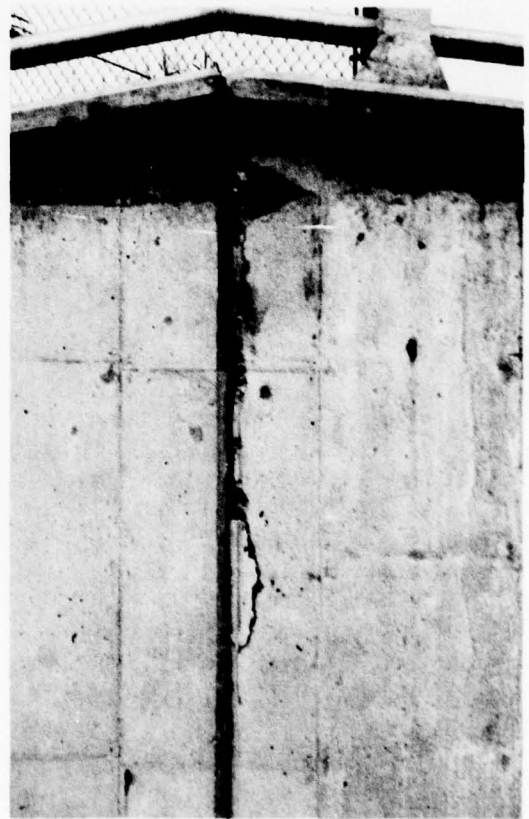
3.1.2 Concrete Gravity Control Structure and Emergency Spillway: The dam modification was completed in 1973. The reinforced concrete flume, walls, and the concrete gravity control structure generally appear to be in good condition. There are some minor surface cracks along construction joints of the concrete wing walls (See photographs in Appendix C).

RETAINING WALL JOINT WITH SPALLING  
ALONG STORM WATER FLUME
